# Report on a Visit to the flood affected lower Gori Valley , Pithoragarh District, Uttarakhand, India

13 to 16 July 2013  
Himal Prakriti<sup>\*†</sup>

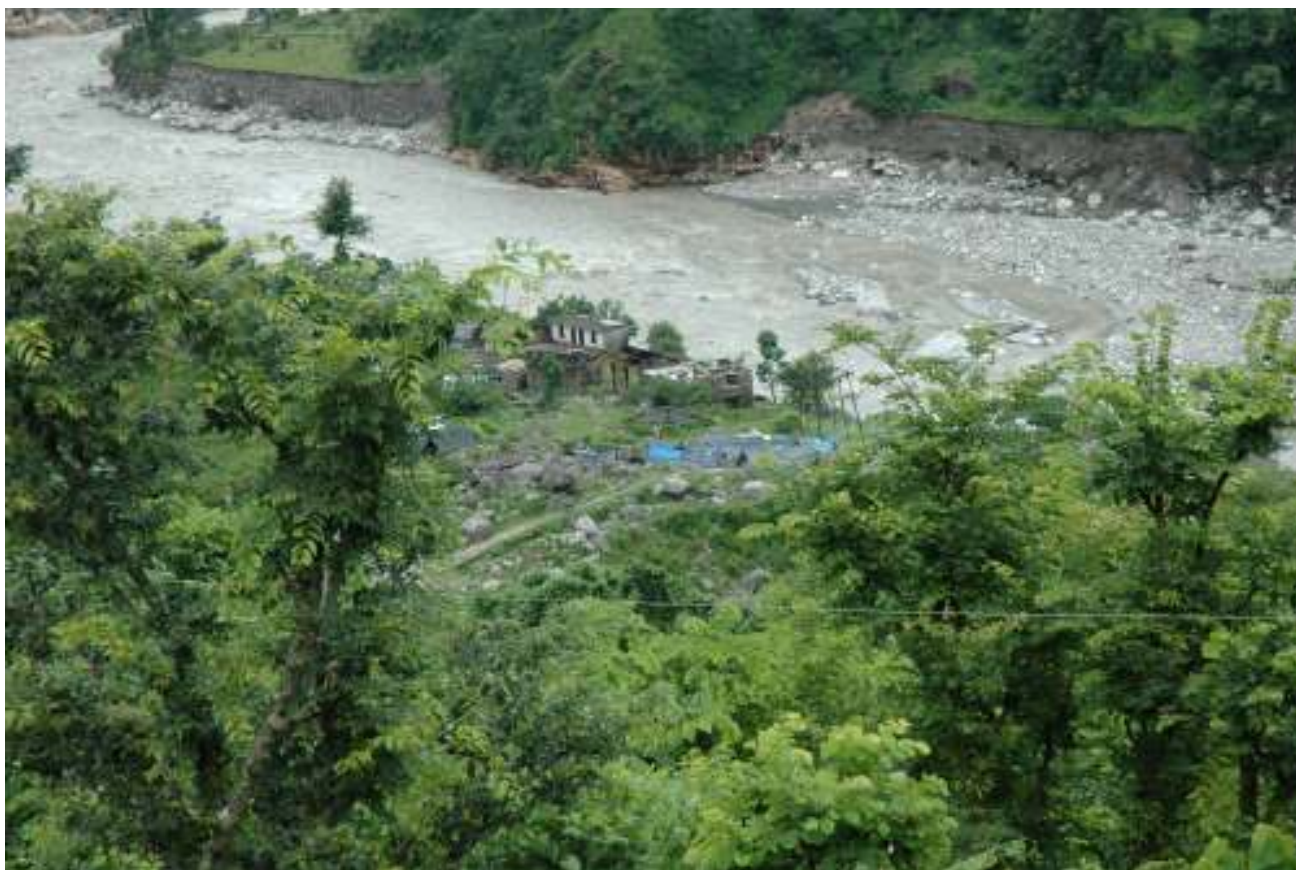
Figure 1: Umaragada: The village is now right at the edge of the Gori river, the 14 families have abandoned their homes and are now living makeshift shelters just a bit further away from the collapsing river banks

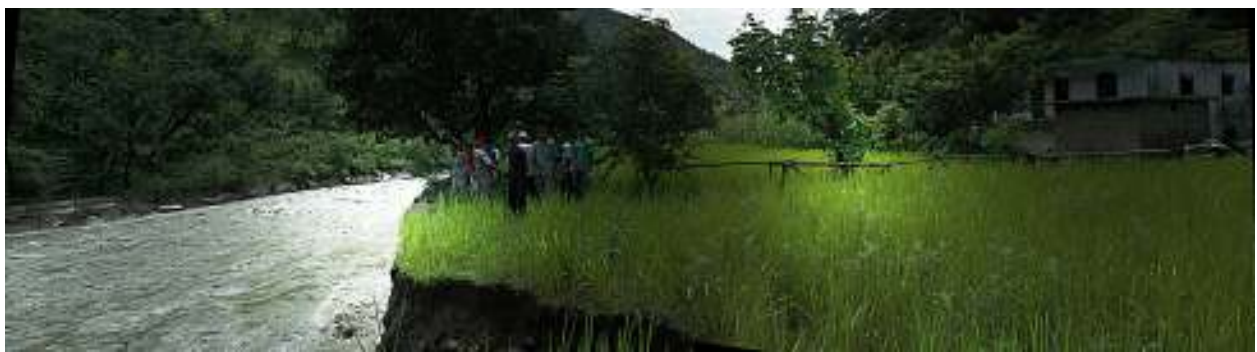
Figure 3: Mankot Village - the floods have washed away significant sections of agricultural land. Here land with standing rice crop has been destroyed and also the river edge is now fairly close to the home on the right

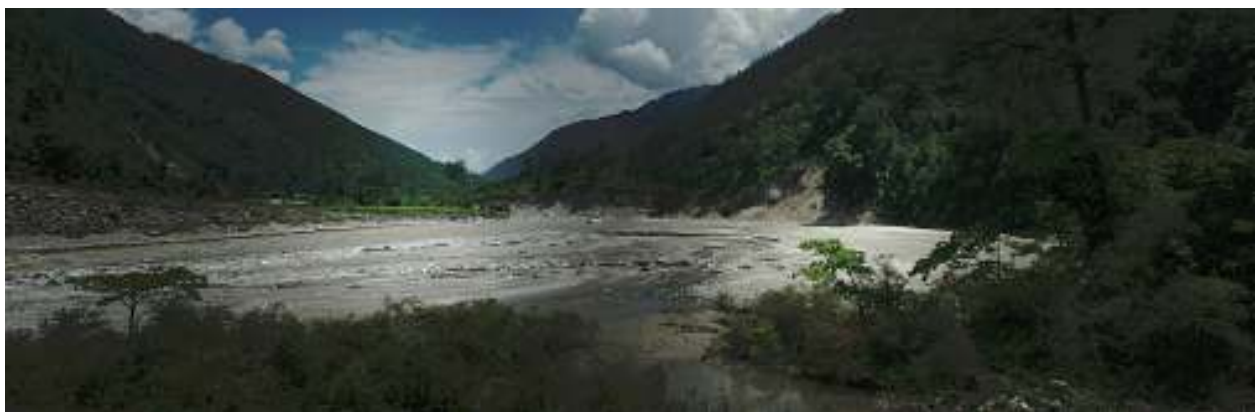
Figure 4: A widescape image of Mori (left) and Gharudi (right) . The Gori river at this point now has a span of more than 300 meters, the floods caused significant land loss in Mori

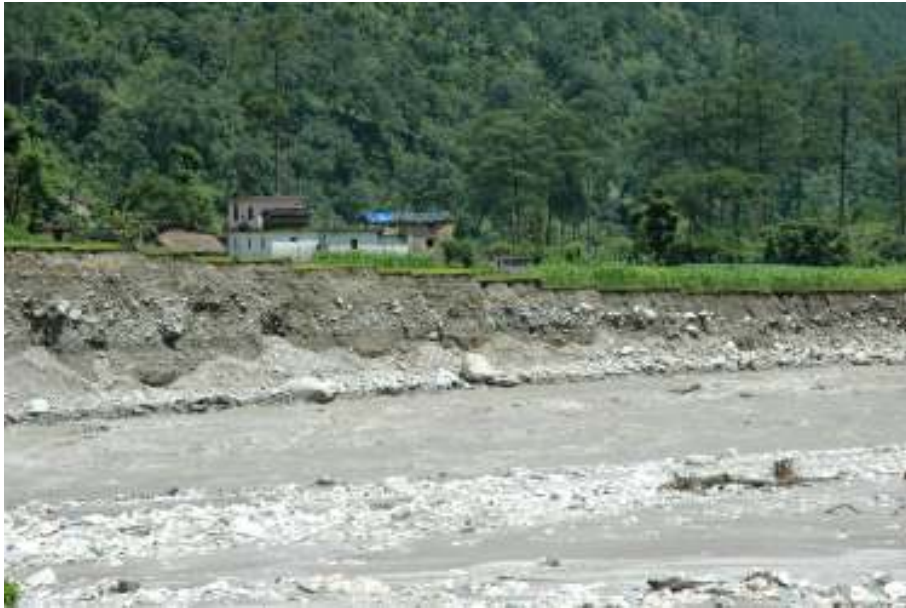
Figure 5: Mori (Talla) Village, the village was once 200 meters away from the Gori river, not only have they suffered immense land loss but the village is now right on the edge of the river

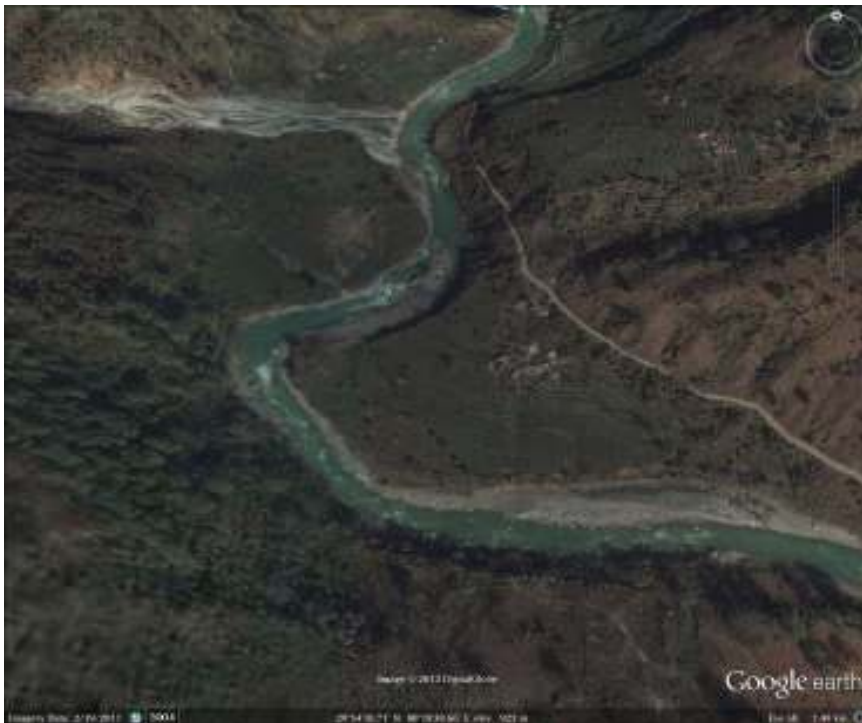
Figure 6: A Google earth image, from 2004, showing Talla Mori village, to the center right, located at a safe distance of over 200 meters from the Gori river. Here not only has the river changed course but has created a new flood plain on the left (the true right bank).

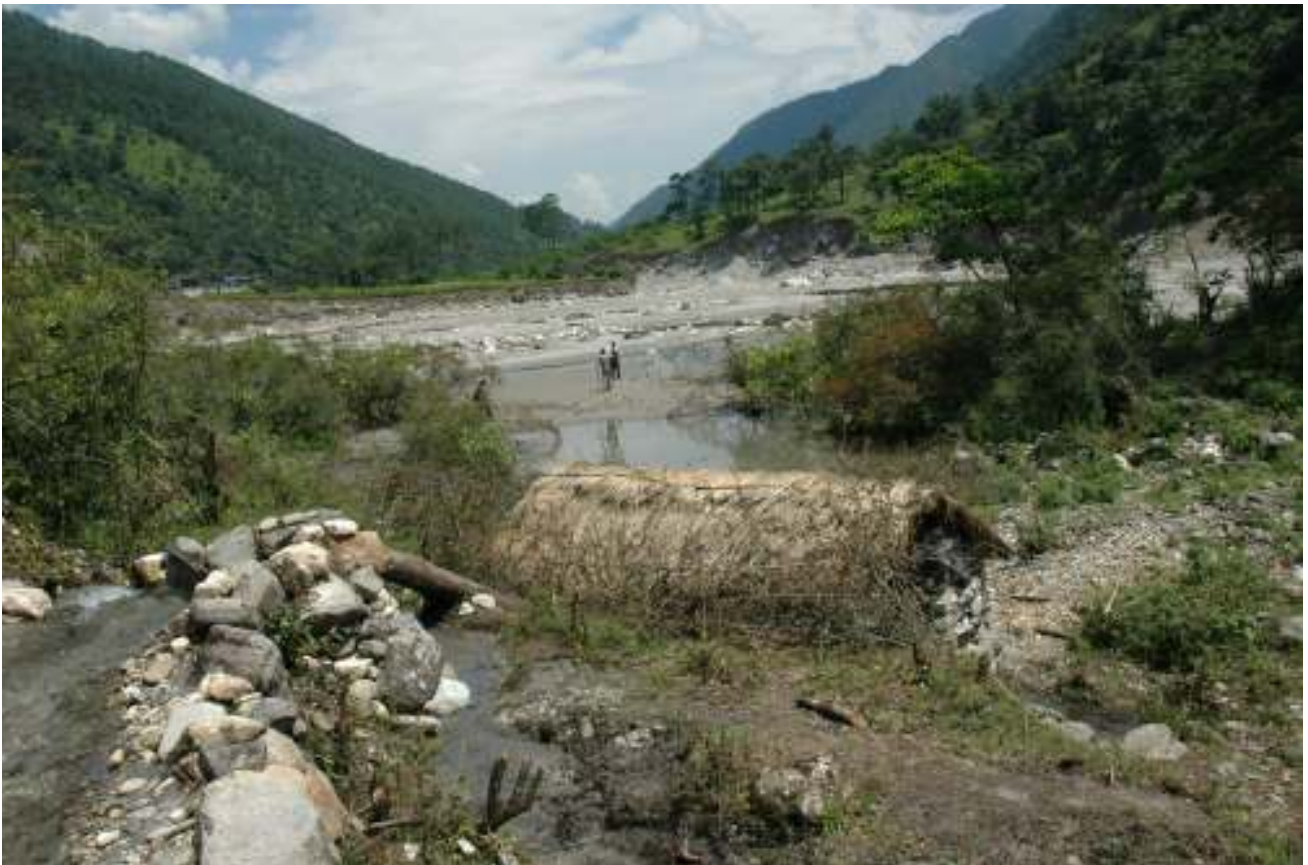
**Watermills** – In the valley there is only one watermill that is located on banks of the Gori river, this at Gharudi. The floods have swept this watermill away. However with lack of diesel fuel to run the mechanized flour mills, communities have had to resort either to hand turned mills or to quickly remake a watermill, as they have done in Gharudi (picture on the current page). Some other villages located along other streams continue to have access to functional watermills.

Figure 7: The reconstructed watermill in Gharudi / Talla Mankot

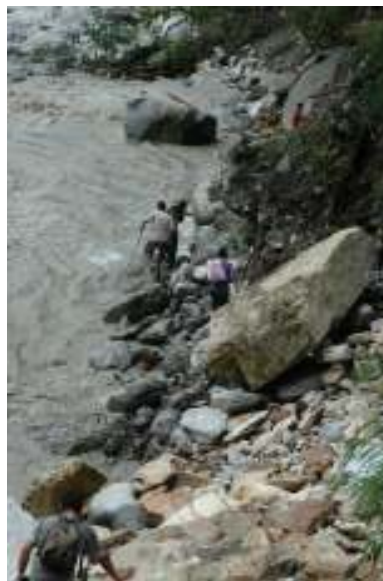
The image on the current page is section of the route from Bungapani to Mankot. In a few places one is required to descend to the river bed and wade in the Gori river. The unpredictability in the flow of the river and the many landslides on route make river sides paths tenuous and dangerous for normal usage.

Figure 8: The route to Mankot necessitates wading in the Gori river for some parts of the way

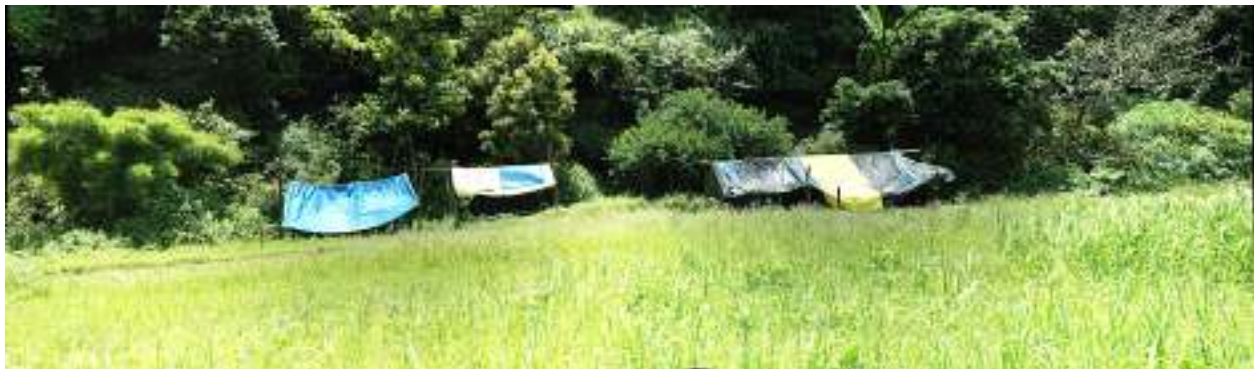
Figure 9: Makeshift shelters in Mankot, where families leave their homes every night because of the risk posed by the Gori river which continues to be in spate.

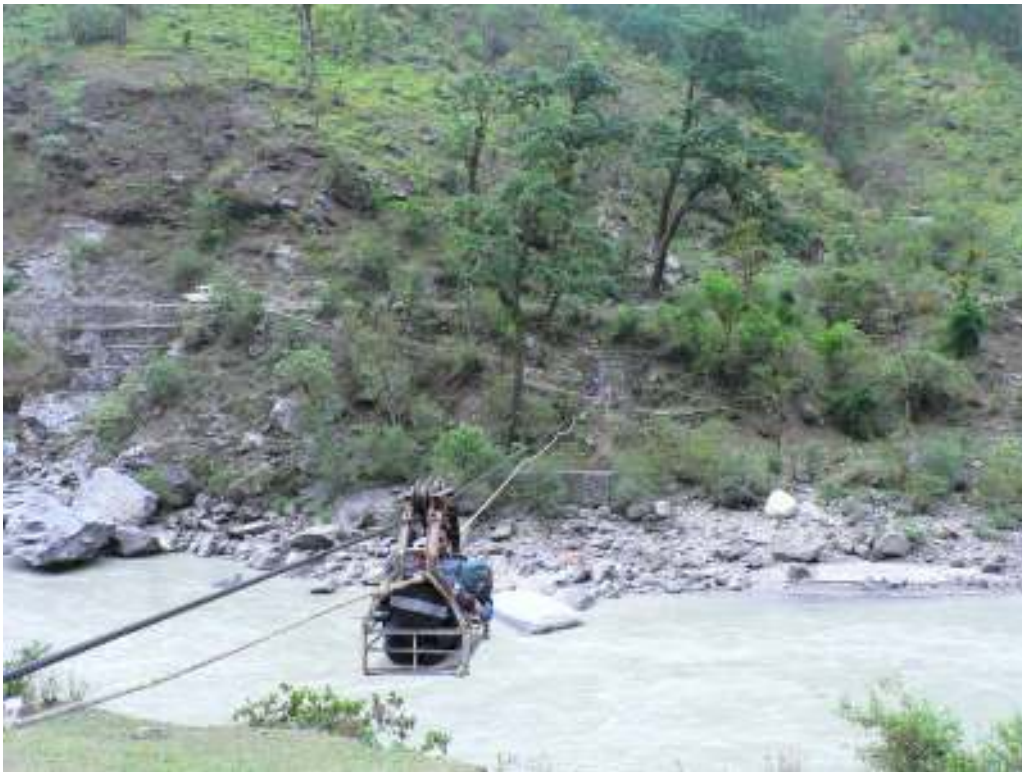
One observation, which needs further confirmation and analysis, was that some areas most affected by the flooding river were where the roads were built. One theory is that the blast and dump technique used by the road building agencies had weakened the slopes and resulted in compounded damage.

The two images on the next page and on the following page, taken from Mankot clearly indicate the existing structural damage to the slope caused while constructing the road in the first instance and the subsequent landslide triggered by the recent flood. Such evidence is visible across many section of the road.

Figure 10: Mankot rope trolley (2008) - Note the structural damage to the opposite slope on the left. People in the village said that the landslide happened when road building was undertaken in the early 80's

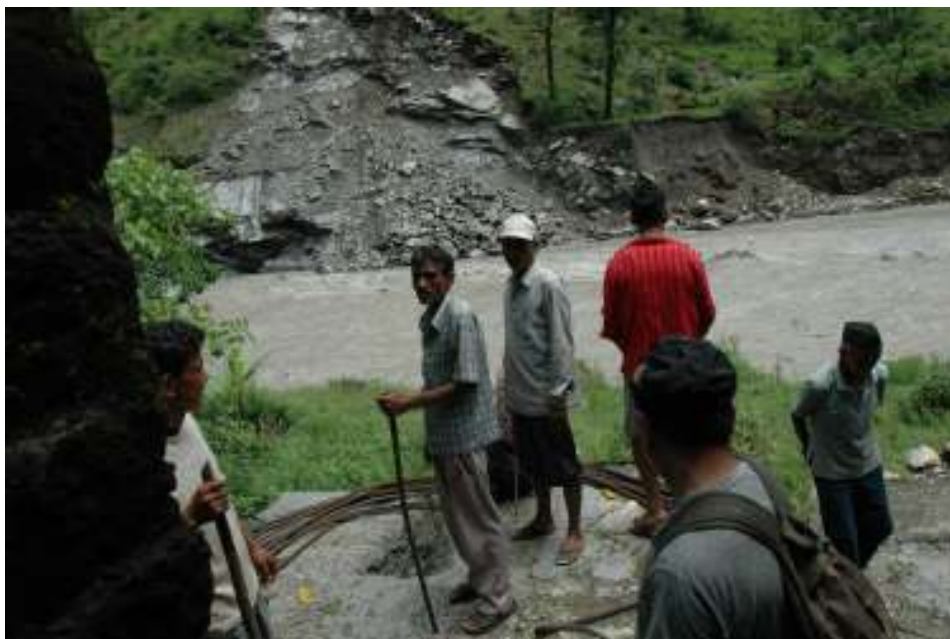
The images also show a before-after depiction of the landscape. The before is when they had a functional rope-way trolley and the after is a post flood scenario – where not only from the left bank abutment been washed away but the slope is now too unstable to build a new one, necessitating the search for a new and more secure sight.

Figure 11: Mankot Rope trolley (2013) - After the flood; again note that the section that has given way is almost co-terminus with the road building induced damage. The abutment on the opposite side has caved in and has been swept away.

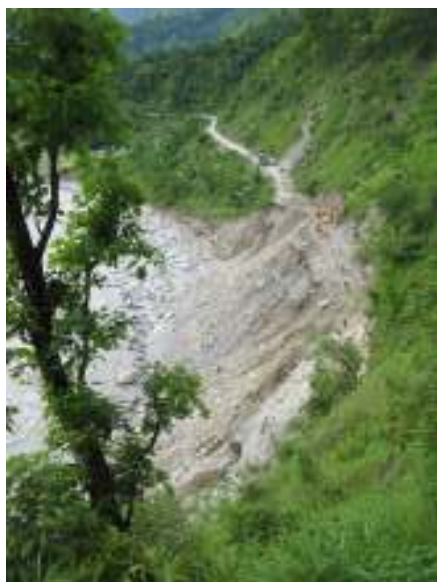
Figure 12: The new landslide at Toli, which is the current road head location

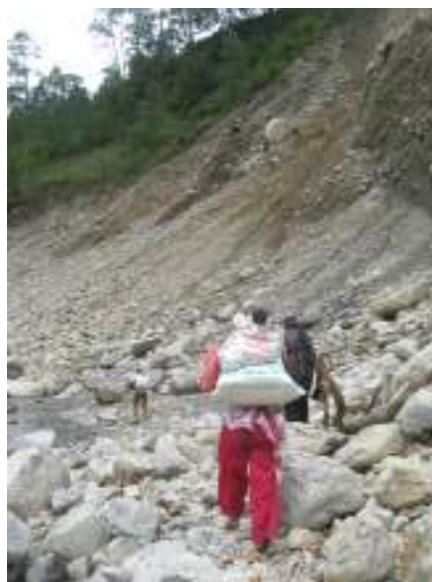
Figure 13: Carrying supplies across an active landslide & a boulder filled path along the river near Mori

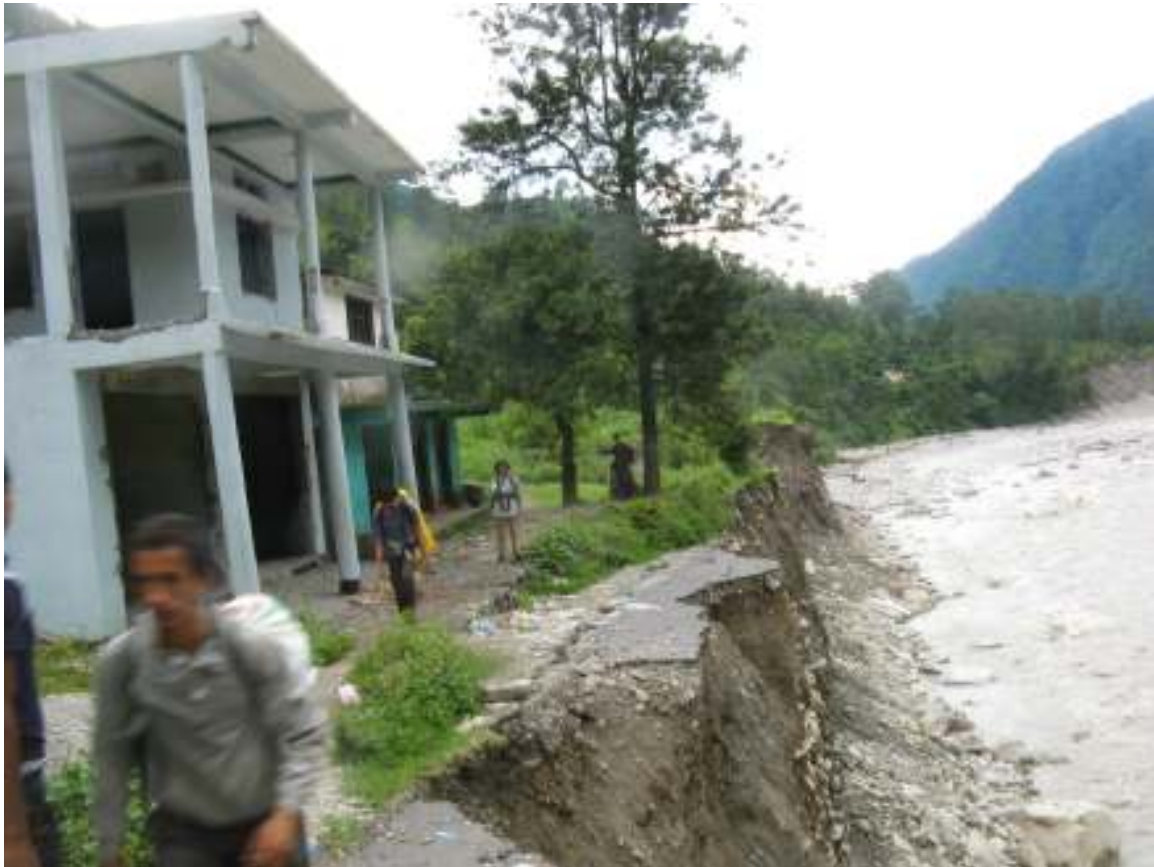
Figure 14: Lumti Village - Abandoned shops and homes, the habitation that existed on the right side of the road has been totally destroyed in the floods

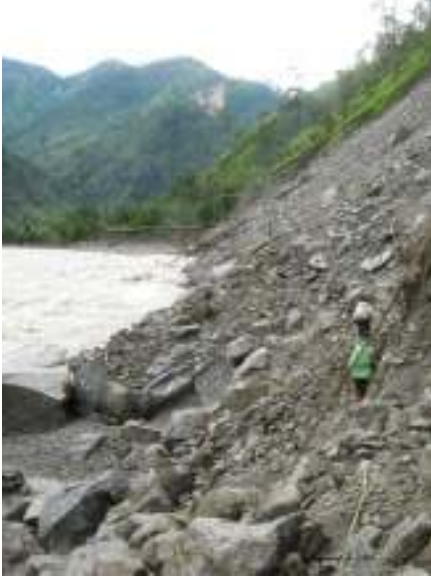
Figure 15: The path lies on the newly formed unstable landslide near Mori

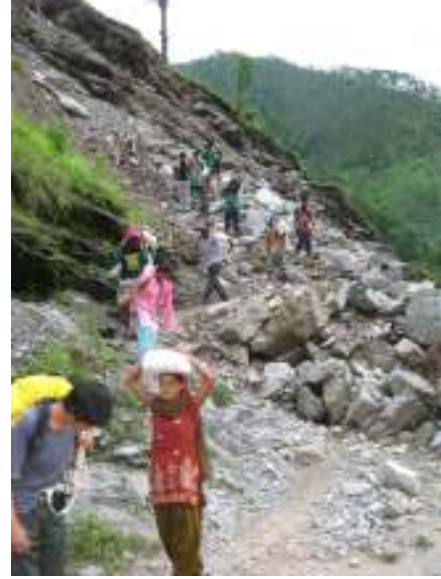
Figure 16: Descending from one of the many landslides - this one opposite Mankot

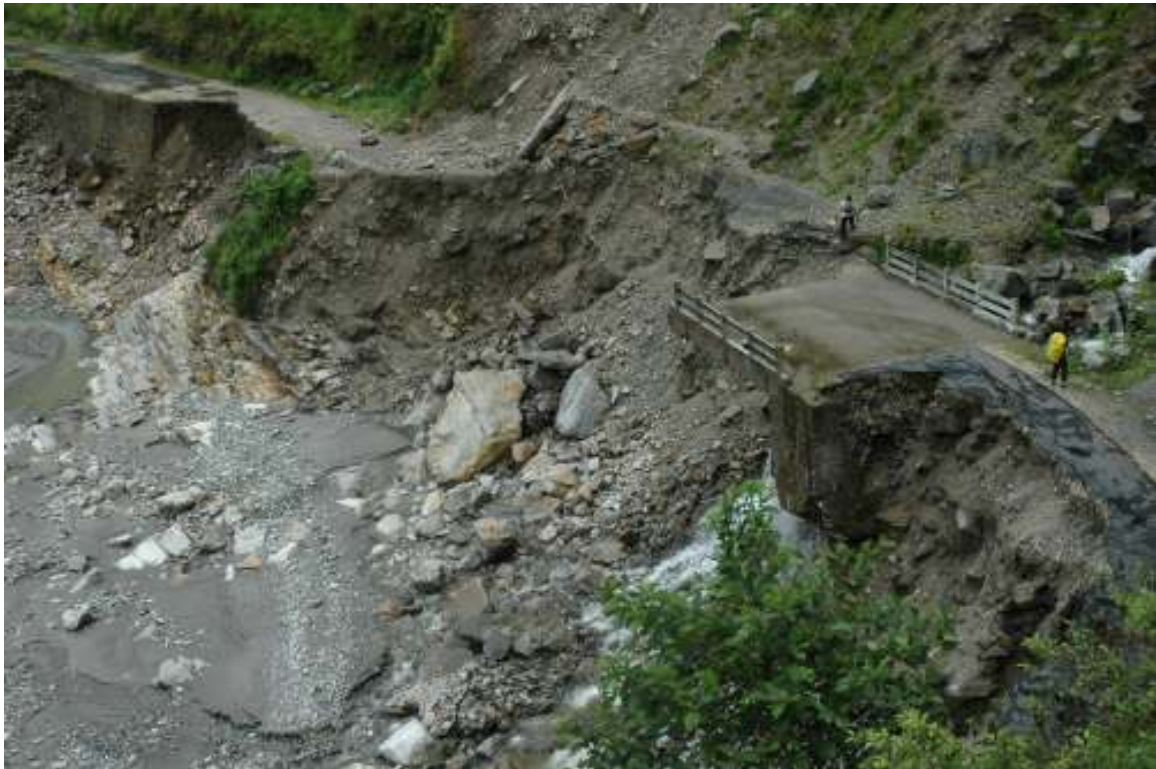
Figure 17: A destroyed road and bridge between Bungapani and Umargada

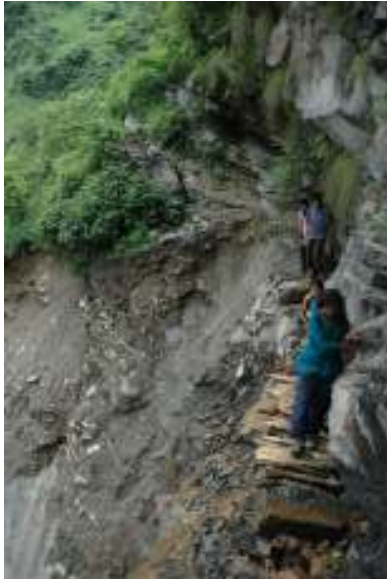
After Khinwagaon a few sections of the motor road have caved in and are barely walkable and soon after is a extremely dangerous temporary path made by the Border Roads Organization (BRO). The path has no protection and is on smooth rock and slippery clayey mud. The BRO have fixed metal ropes on the lower side (the falling side) instead of on the upper side, and these ropes are totally useless for any except when they have already fallen and even then will be of no help. There is a longer and safer detour which takes about 2 hours and involves a steep climb and an equally steep descent through Chir pine forests and grassy slopes with no established path except what has been created by people walking and some old animal trails.

Figure 18: temporary and dangerous path between Khinwagaon and Umargada

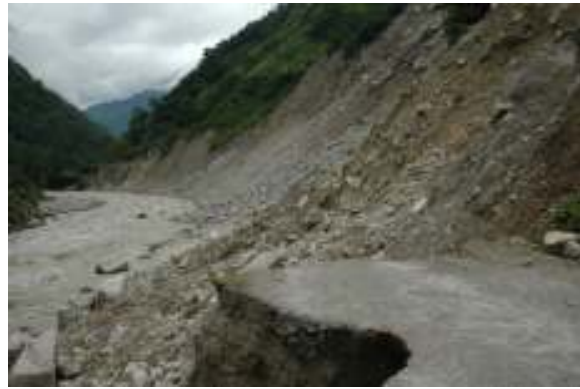
Soon after crossing the Jauli gad (between Umargada and Shilling) is the Ghingrani landslide. This is an old and perpetual landslide originating from the river to a few hundred feet up and is quite long, about 300 meters. Over the last few years this landslide had stabilized and in the monsoons was kept open by the BRO. However the floods have once again destabilized the landslide which has now become longer, steeper and very unstable. Earlier in the middle of the landslide was an unaffected section – this has now become part of the landslide as well. Also just a bit after Ghingrani a new landslide has got formed. This entire section is not negotiable and one has to take a footpath that climbs up much higher to the main Shilling village and then a descent to Sera Village. The distance of normal motorable road from Shilling to Sera is about 3 kilometers however the diverted footpath route is close to 5 kilometers involving a longish climb and descent.

Figure 19: Ghingrani Landslide near Shilling, with little evidence that there was a road here before

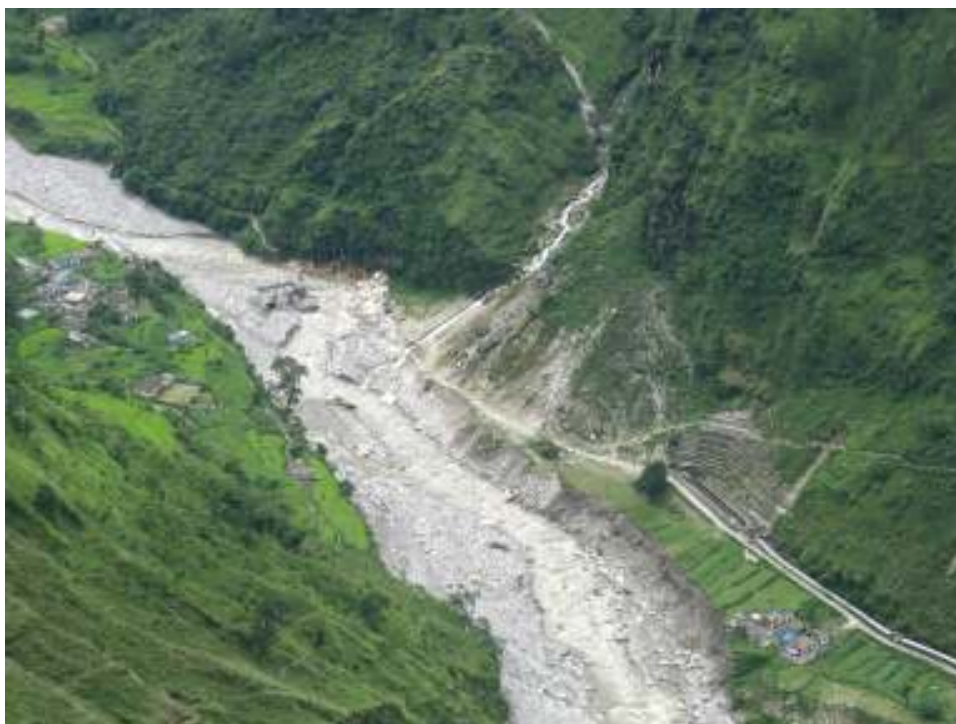
Figure 20: View of the Paina River, a tributary of the Gori. Visible are – Centre Left - the destroyed barrage of the 5 MW Motighat Hydro Project, Right – Washed away farms and precarious homes of Lodi Bagad hamlet and Left Dani Bagad Hamlet

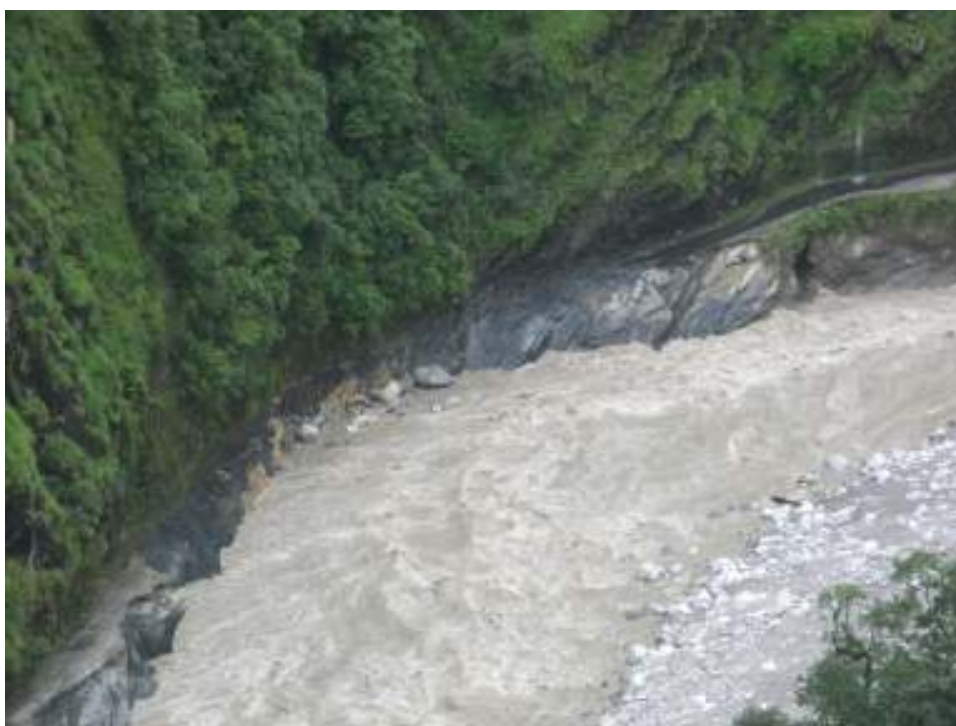
Figure 21: What remains of the motor road at Phaguwa Bagad, between Madkot and Seraghat
